MACHINE SHOP BUILDING IMPROVEMENT PROJECTS

By Dave McClary

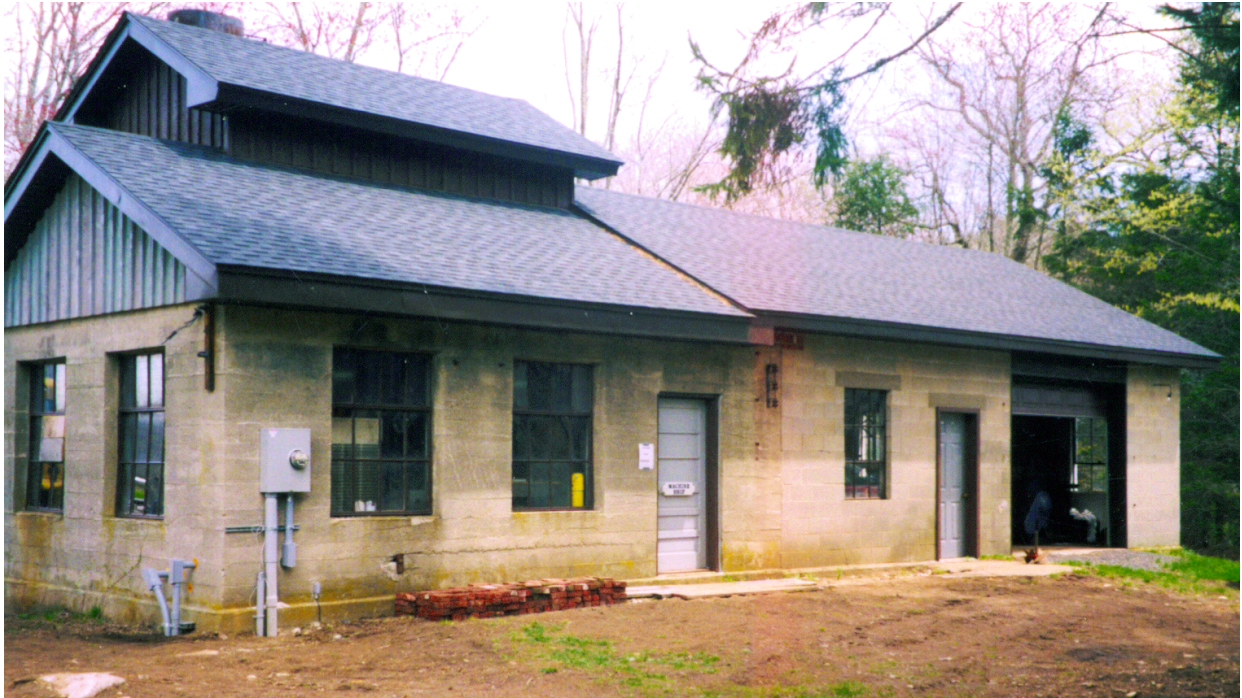
Machine Shop with new roof and electric service before later painting

1. The CHS engaged a contractor to re-roof the building and refurbish the so called cupola, a small, second floor room. Inside access to the cupola was provided where climbing a ladder and crossing a shed roof was previously required. Also, a new concrete stove chimney replaced rusty stovepipes, and a new roll-up door was installed. Steel factory style windows were refurbished. See the picture on the next page.

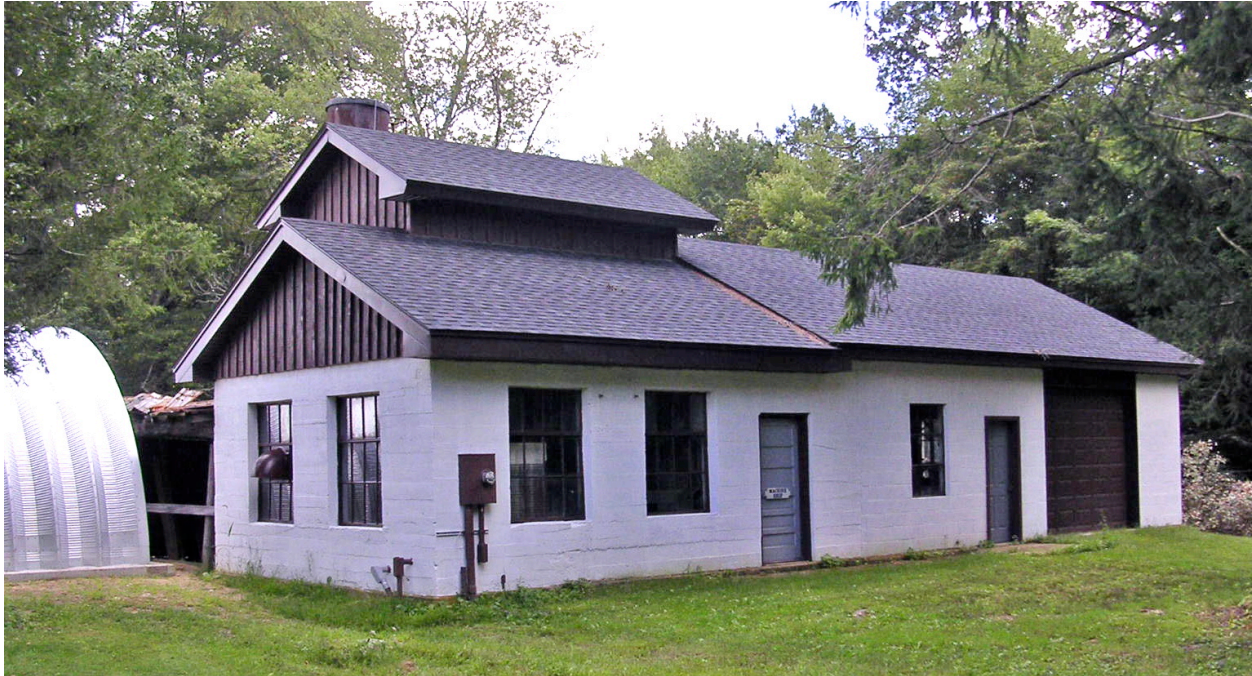
Paint greatly improved the appearance of the building. Seen at the left is the end of the new Quonset hut described below.

6. The outside of the machine shop was painted by members to improve the appearance of the old concrete walls and wooden trim. The major portion of the outside of the machine shop had not been painted and it showed in the discolored appearance. Because of its exposure to the weather, the concrete was coated with a paint intended for use in damp environments. The south side had been coated so it was left as is with some minor touchup. Inaccessible areas on the back wall were completed at a later times when the foundry shed was replaced. This painting greatly improved the shop appearance as seen in the picture on the next page.

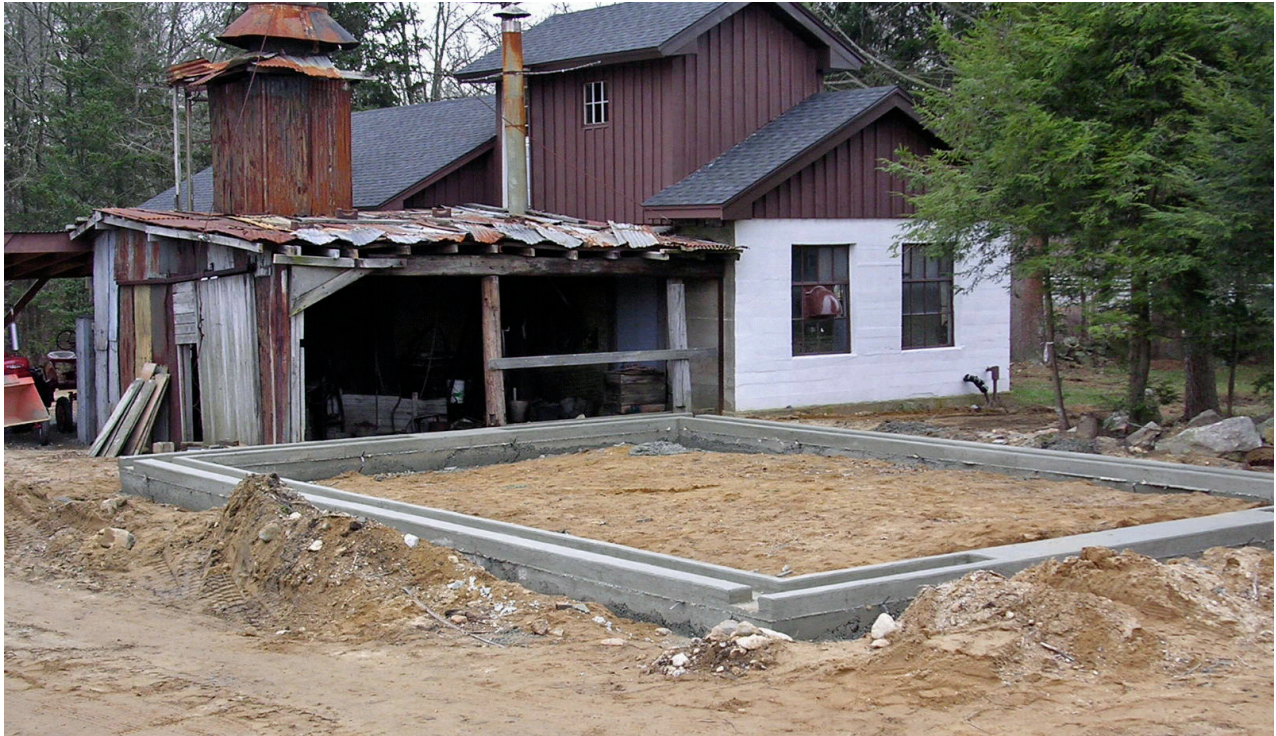
The perimeter foundation for the new Quonset hut. Note the dilapidated foundry shed.

Members erected the new building which is made up of seventeen arches bolted together with the ends of the arches set in a four inch deep trough of the perimeter foundation. Poured concrete was used for the interior floor. The trough was grouted in with cement when the structure was complete and the ends installed. A roll-up door was installed on one end and a double door on the other. Lighting completed the building and allowed the door to be closed if inclement weather occurred during shows. See the pictures on the next page.

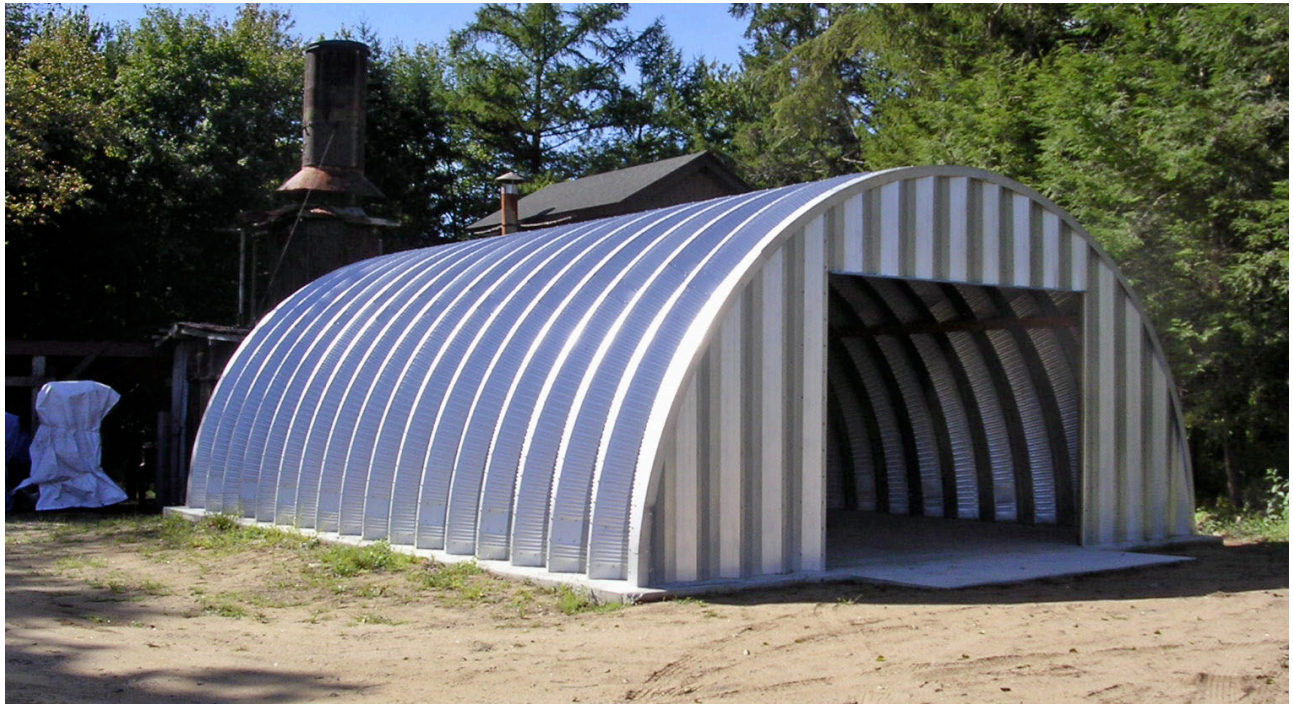
The nearly completed new Quonset hut with floor poured and grouting completed

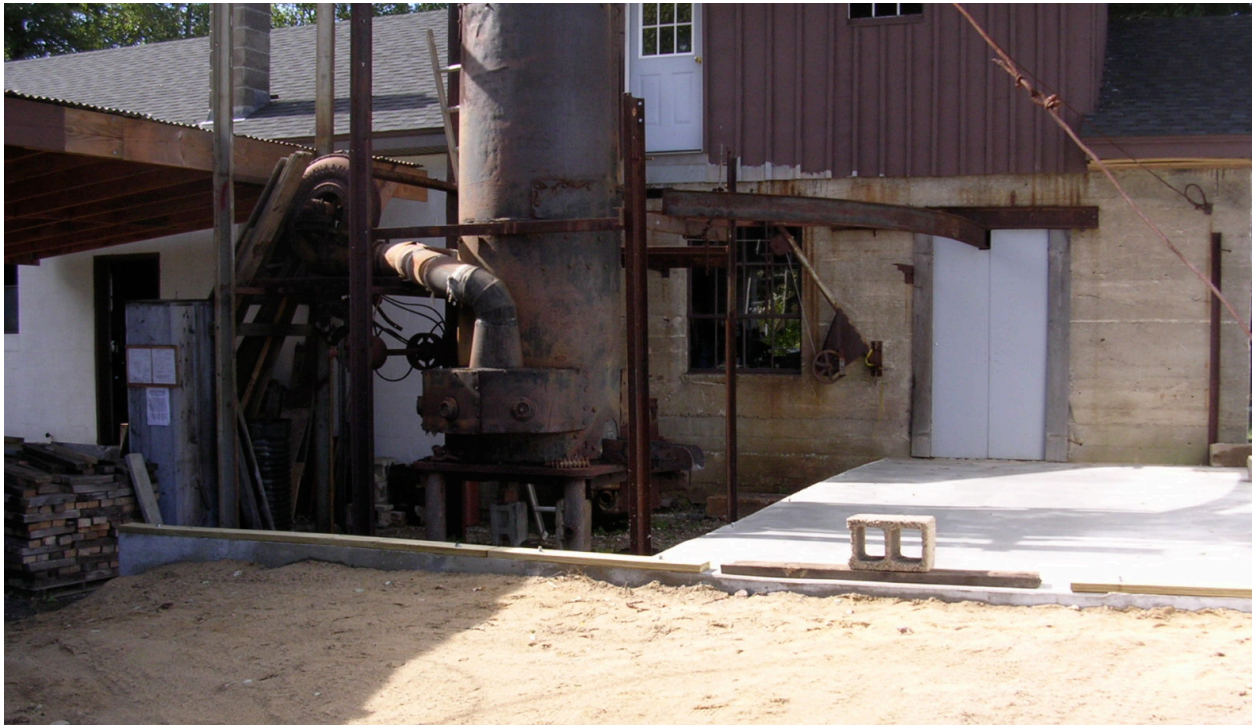
A new concrete floor for half of the foundry shed and a foundation for the back shed wall are in place ready for construction of the new shed.

8. A dilapidated shed roof and enclosure around the cupola furnace in back of the shop is seen in the top picture on the previous page. It was removed and replaced using properly sized structural timbers and corrugated iron sheets for covering. The roof slope was changed to be towards the roadway for water run-off away from the shop and Quonset hut. Approximately half of the area under the roof was brought up to the level of the shop and Quonset hut floors with new concrete. A railing separates the upper level from the area used to display foundry tools. New clear fiberglass siding was installed for the shed that enhanced the visibility of foundry equipment stored there. This improvement was completed by members with contractor assistance for the concrete floor.

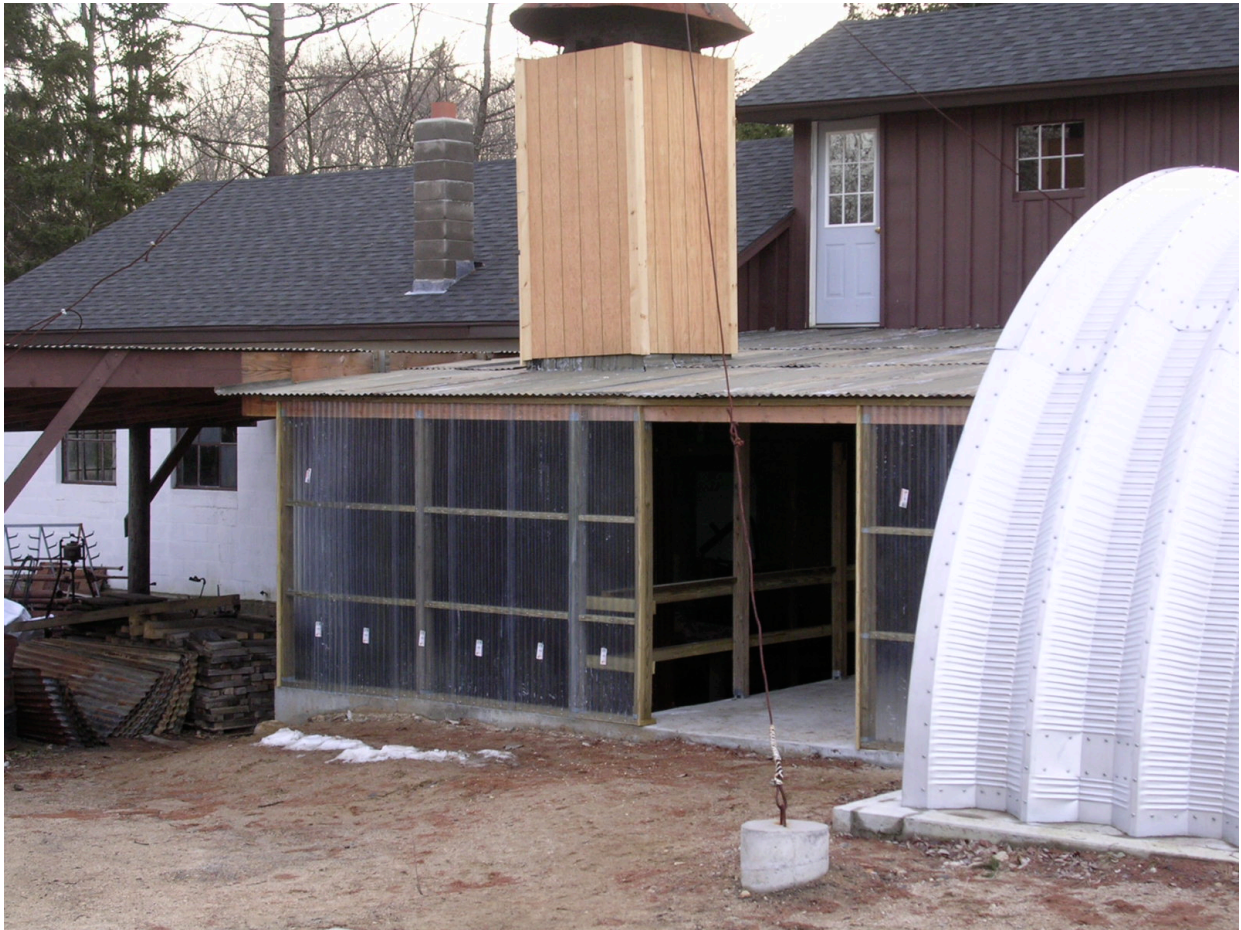
Picture shows the completed building and shed complex that makes up the Machine Shop museum

The new foundry shed is shown essentially complete on the next page. Clear corrugated fiberglass panels make up the wall to provide natural light under the roof. Two doors for the opening are wide enough to allow access for movement of small but heavy equipment into the Machine Shop or Quonset hut . A new wooden enclosure around the furnace stack now painted brown improves appearance and weather tightness. The skirt above that enclosure has since been upgraded with an overlay of galvanized sheet metal.
